Field reconnaissance report of landslides triggered by the 2023 Turkey–Syria earthquake

Gonghui Wang

Disaster Prevention Research Institute

Kyoto University

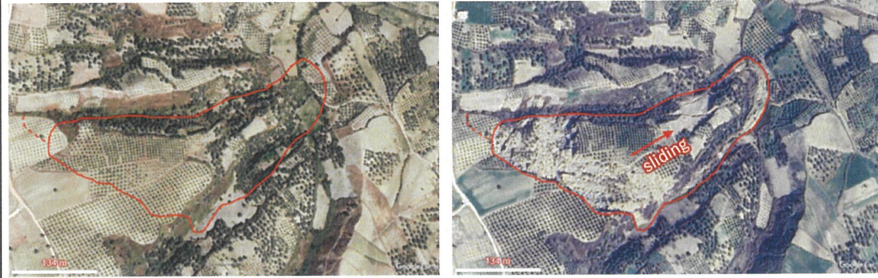
① **Tepehan landslide**

Google earth views

Image on Sept. 27, 2021

Image on Feb. 12, 2023

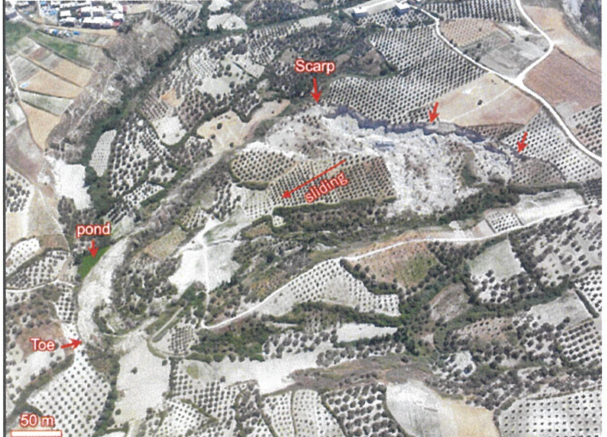
① **Tepehan landslide**

Location: N36 9'39.3"; E36 13'17.9"
Tepehan village, Altınözü, Hatay

Area: about 1.3 km²

Geological setting: marl and clay-rich limestone sedimentary layers.

Uplifted toe part (~10 m), resulting in the formation of dammed pond

Elevation difference in the main scarp: ~20 m

Sliding surface: along the upper bedding surface (about 8~10 degrees) of a clay-rich limestone sedimentary layer (?)

Type: translational earth block slide

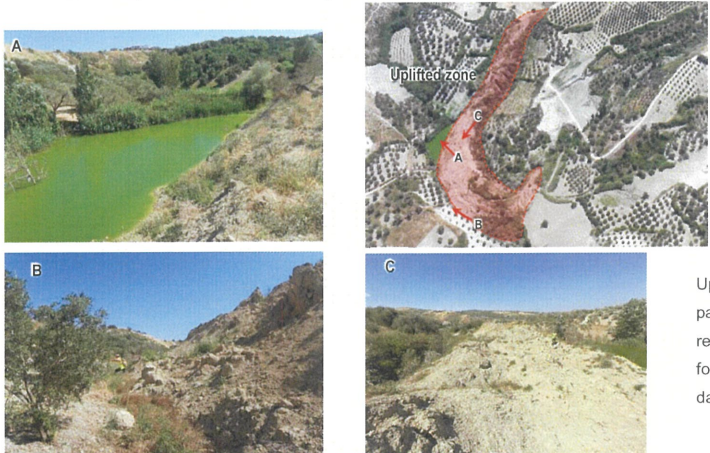
① **Tepehan landslide: uplifted toe and dammed pond**

Uplifted zone

Uplifted toe part (~10 m), resulting in the formation of dammed pond

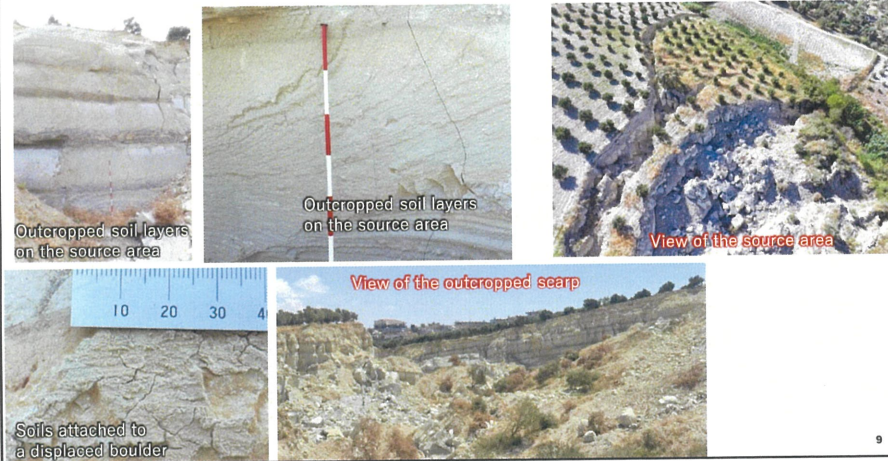
① Tepehan landslide: scarp, cracks, and stratum

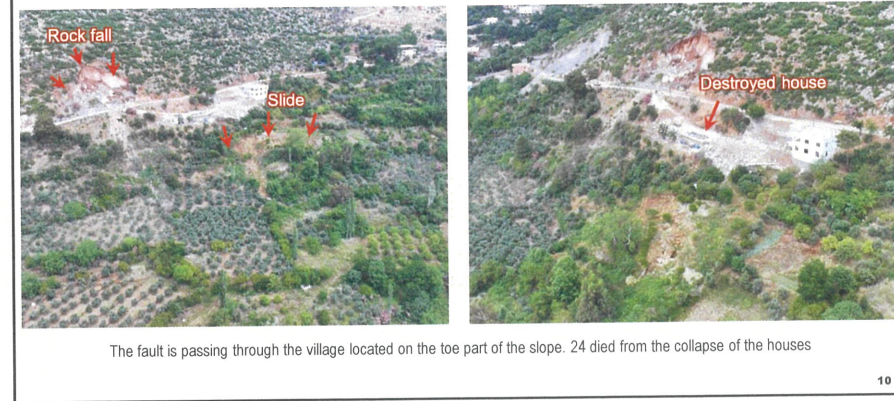
② Rock fall and landslide at Bektasli, Islahiya

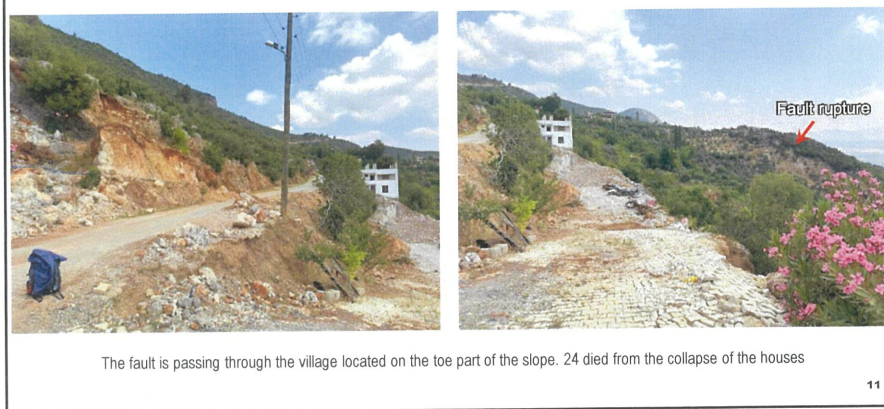
② Rock fall and landslide at Bektasli, Islahiya

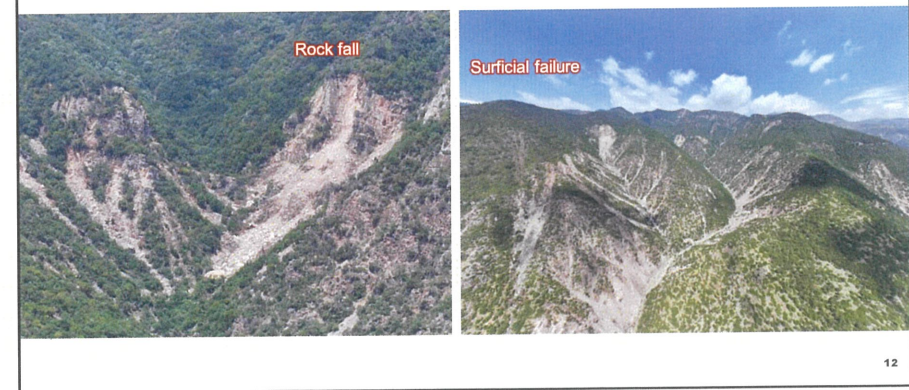
36 38' 50"N, 36 23' 27.2"E

② Rock fall near Bektasli, Islahiya

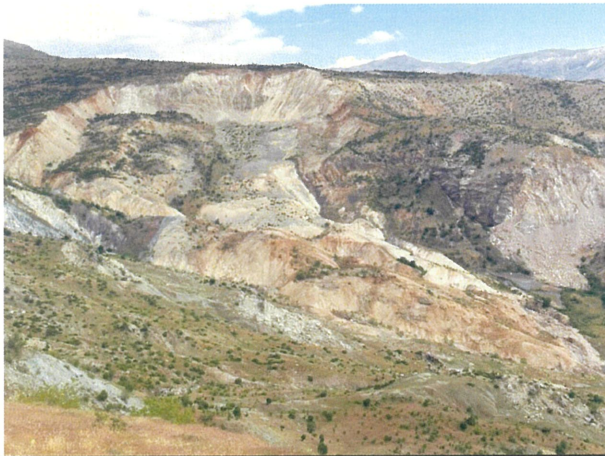
④ A large scale old landslide in Cankara area

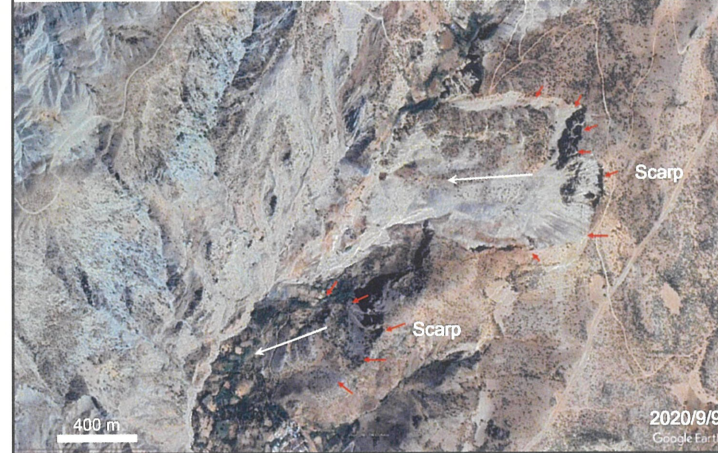
Cankara area, Malatya

④ Earthquake-induced cracks and slope instability in large scale

Old landslides before the 2023.2.6 earthquake

Unraveling the age and triggers will be important

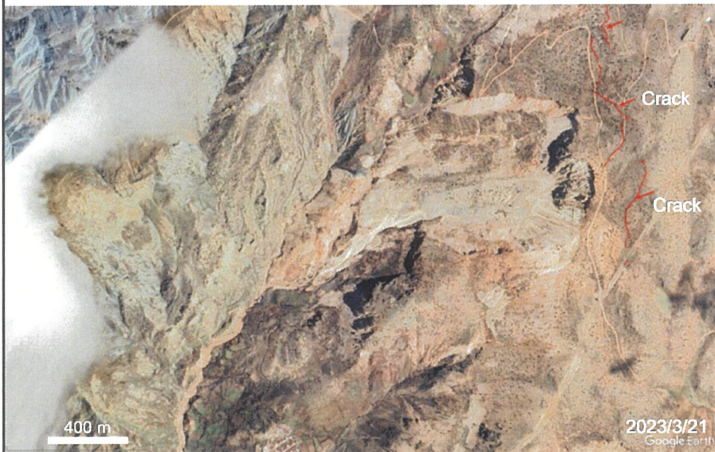
④ Earthquake-induced cracks and slope instability in large scale

The landslide was not enlarged.

But cracks occurred on the upper part of the slope during the earthquake, enhancing the destabilization of the slope.

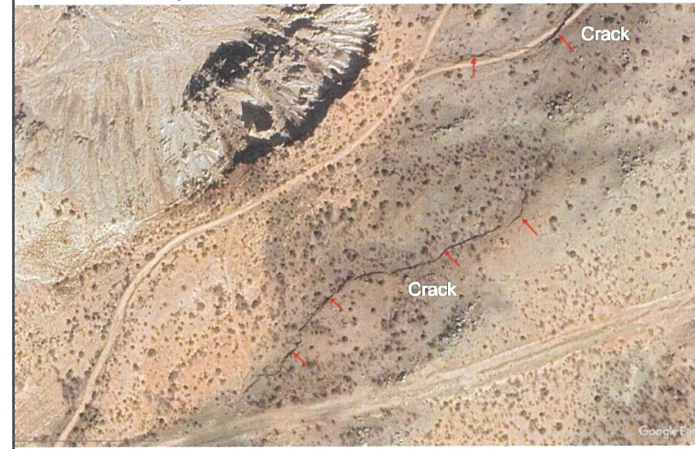
A close view of the cracks

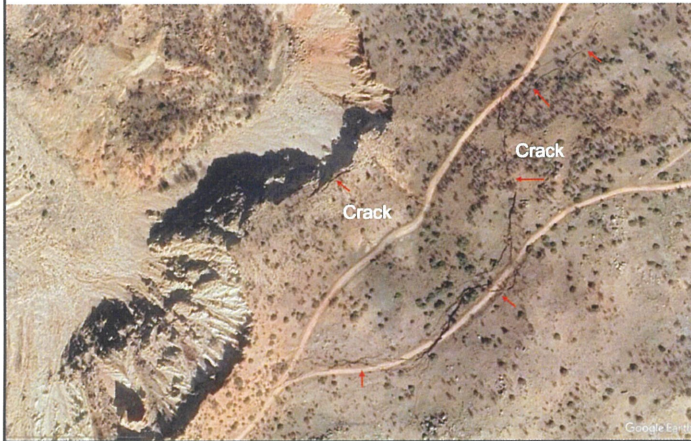
A close view of the cracks

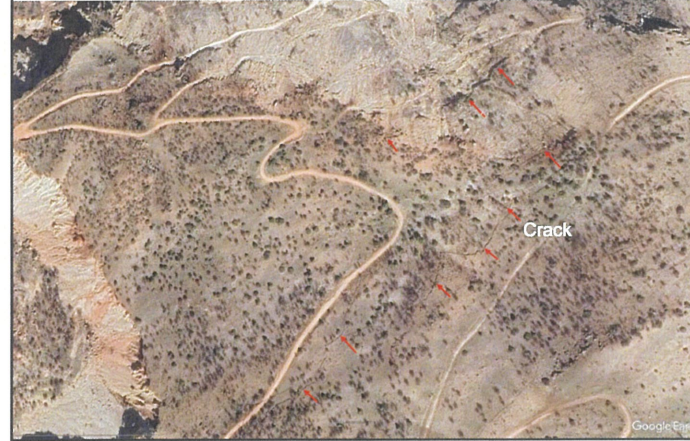
A close view of the cracks

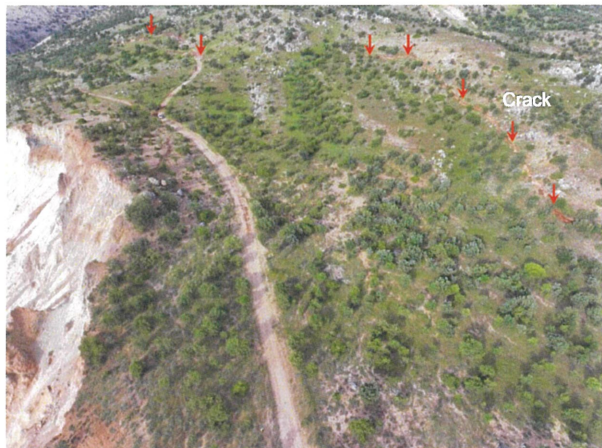
A close view of the cracks

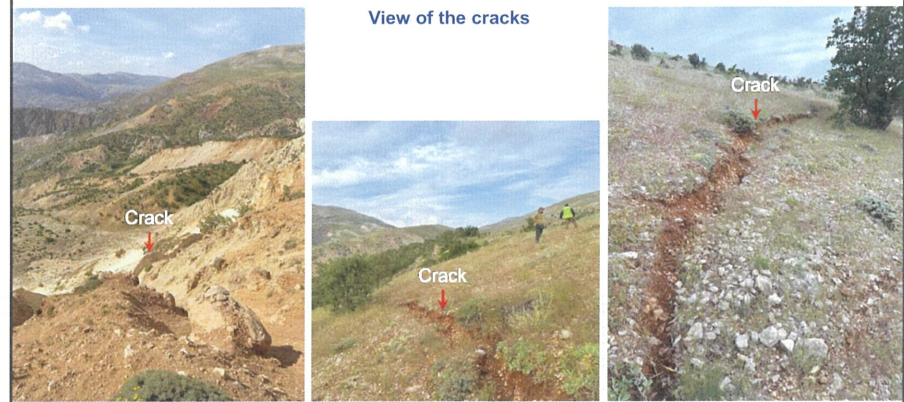
View of the cracks

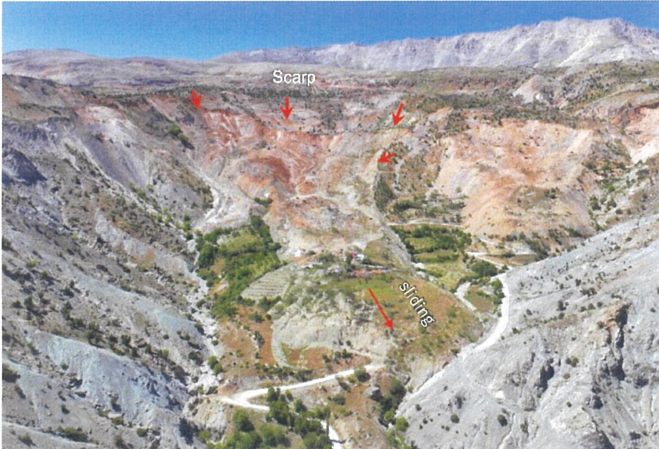
⑤ Reactivated landslide: Incirlik

Geology settings:
Limestone underlain by ophiolitic rocks

Sliding surface :
Along the interface
Between weathered limestone and ophiolites

Landsliding occurred 14 seconds after the first earthquake, and continued for about 2 minutes

Houses moved about 400 meters; 52 residents lived in the village and all survived.

Different sub-blocks with different sliding velocities

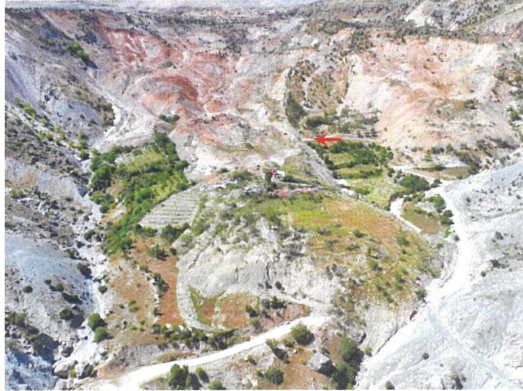
Observation of sliding zone

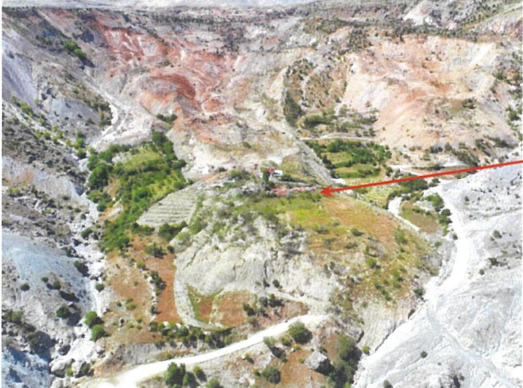
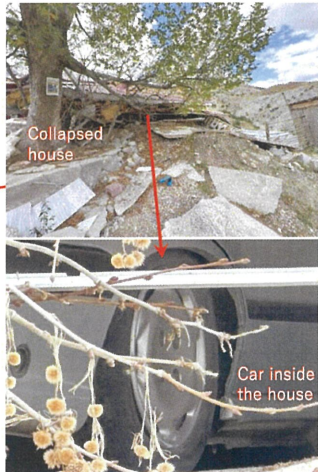
Collapsed house

Car inside the house

Collapsed house and underlain car

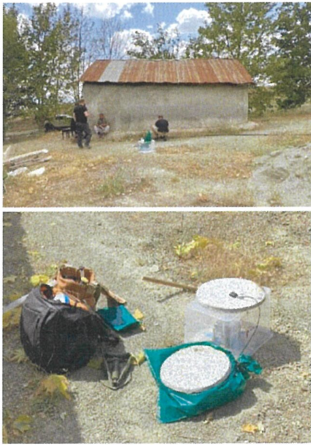
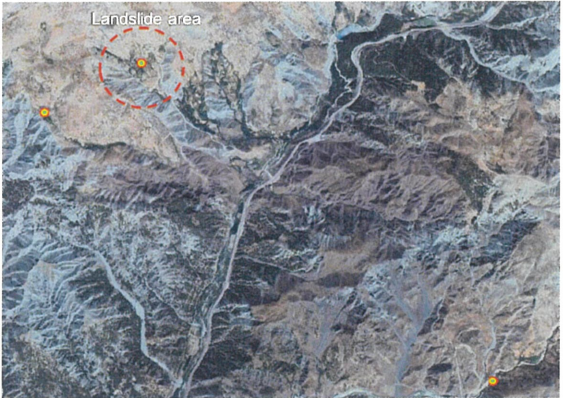
Landslide area

Monitoring of aftershocks (July 17-21)

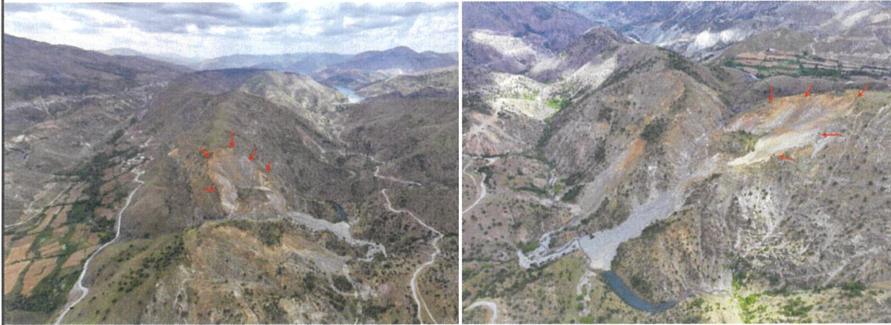
⑥ Landslides in the area near Mutlu village: landslide with dammed river

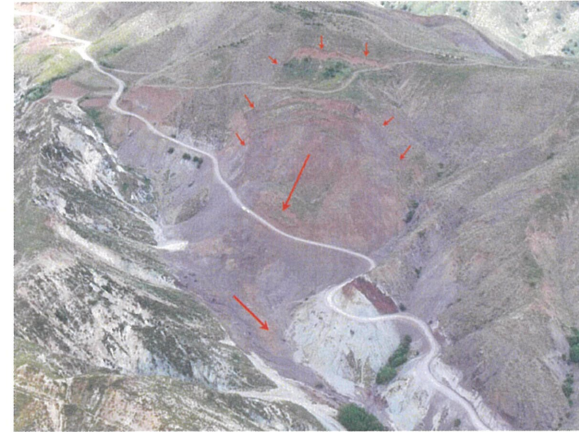
⑥ Landslide in Yesilyayla with long travel distance

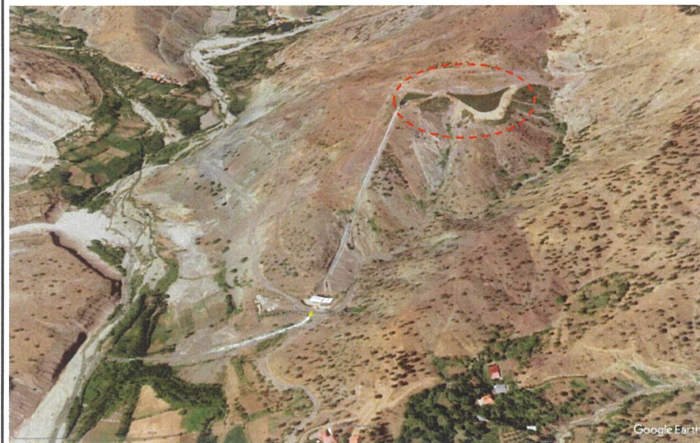
⑥ Landslide in the area near Mutlu village: multiple disasters

The water storage pond of the power station failed, and the downpour water resulted in a large debris flow, which buried the factory of the power station
