Field reconnaissance report of landslides triggered by the 2023 Turkey–Syria earthquake

Gonghui Wang

Disaster Prevention Research Institute

Kyoto University

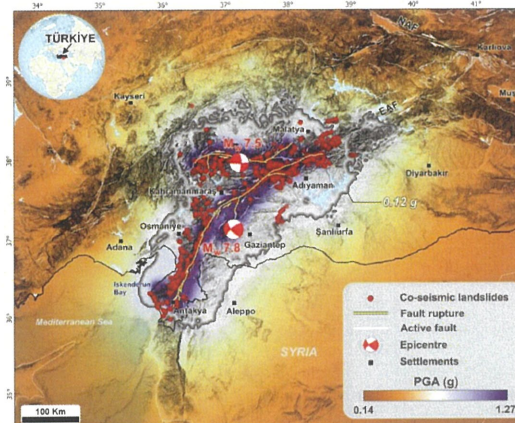
Distribution of coseismic landslides

According to Dr. Görüm (personal communication), more than 3600 landslides of different types had been triggered by the earthquakes

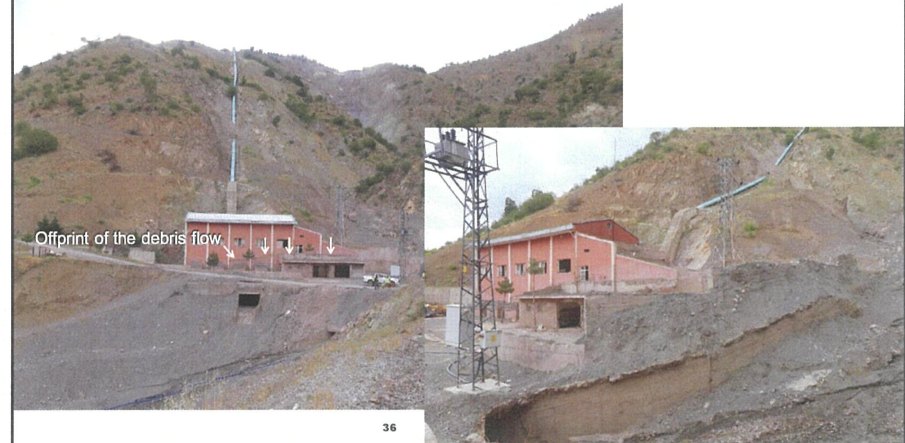
⑥ Landslide in the area near Mutlu village: multiple disasters

The water storage pond of the power station failed, and the downpour water resulted in a large debris flow, which buried the factory of the power station

- Multiple hazards were also triggered. For example, the failure of the water storage pond resulted in a large-scale debris flow that partially buried the factory of the power station.
